# Windstorm Mitigation Affidavit Report

Oak Lake Park I Condominium  
1960 Union St, Units 11, 12  
Clearwater, FL 33763

Prepared Exclusively for Oak Lake Park I Condominium Association, Inc.  
As of 04-03-2026 | FPAT File# MUD2626181

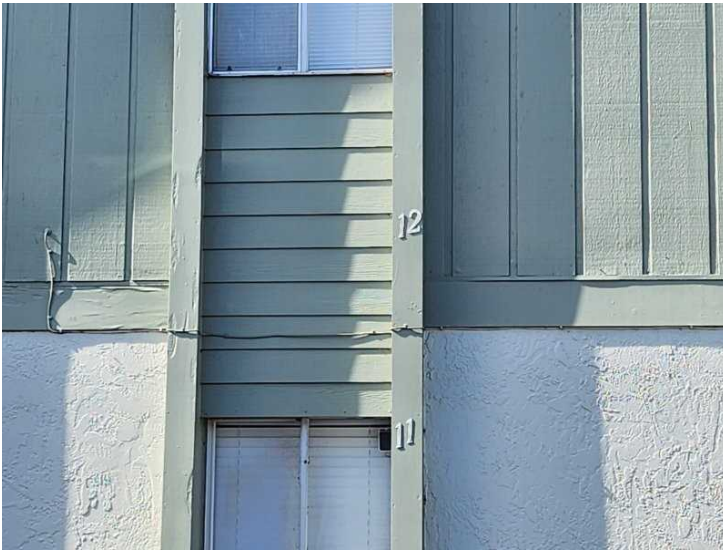
Address Verification

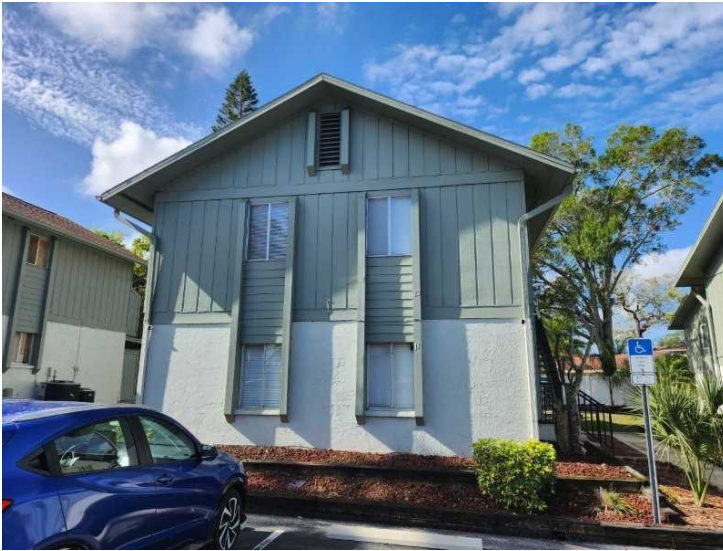
Exterior Elevation

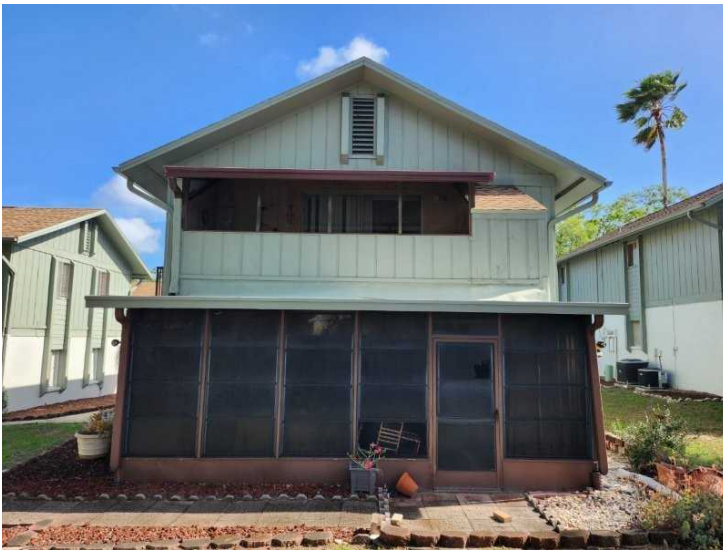
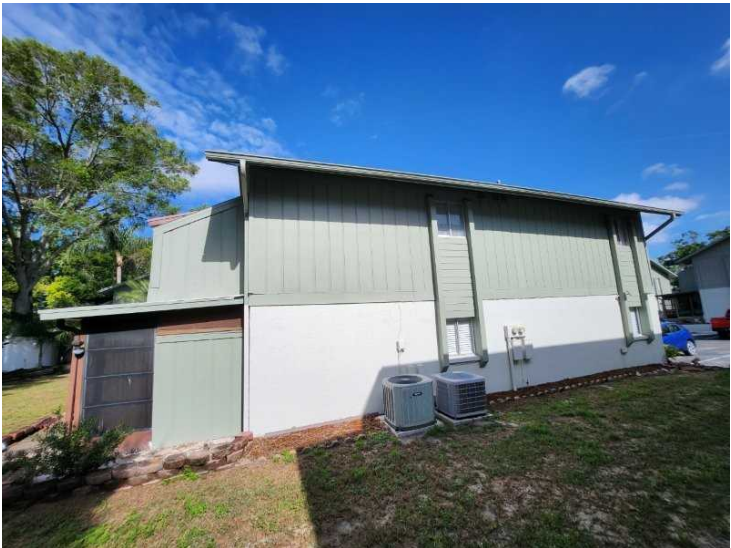
Exterior Elevation

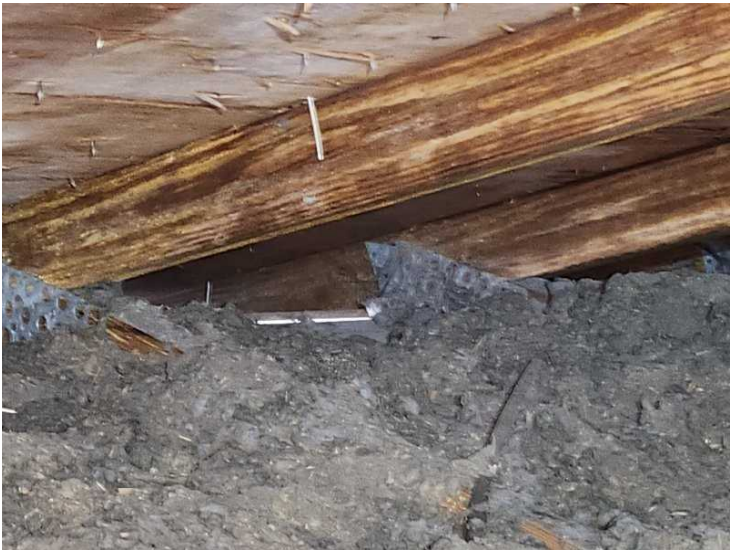
| <b>4. Roof Covering:</b><br>Comments: | <b>A. FBC Equivalent</b><br>The roof covering was replaced in 2020. The roof permit was confirmed and the permit number is BCP2020-110768. This roof was verified as meeting the building code requirements outlined on the mitigation affidavit. |

Roof Permit  
Information

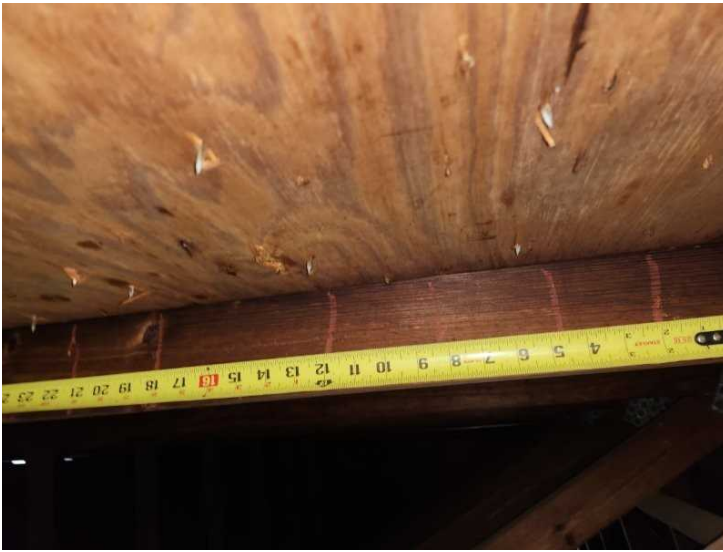
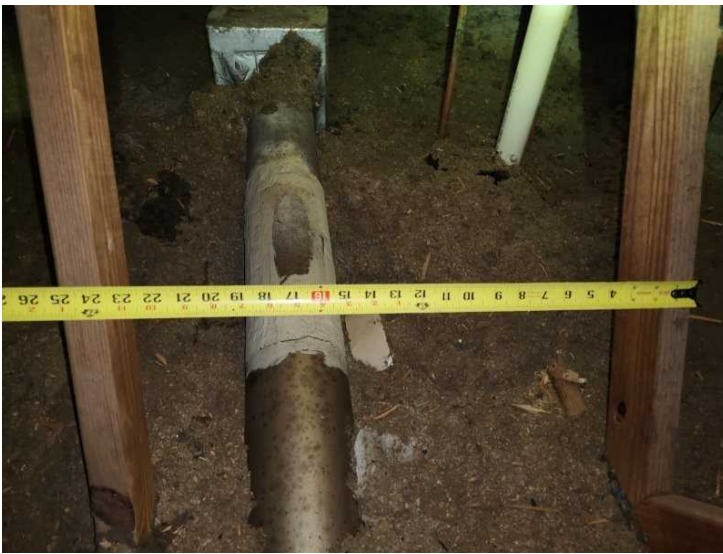
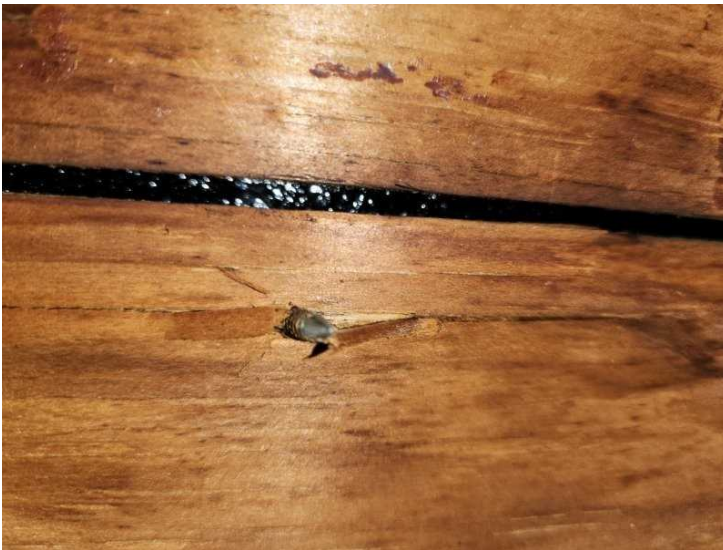
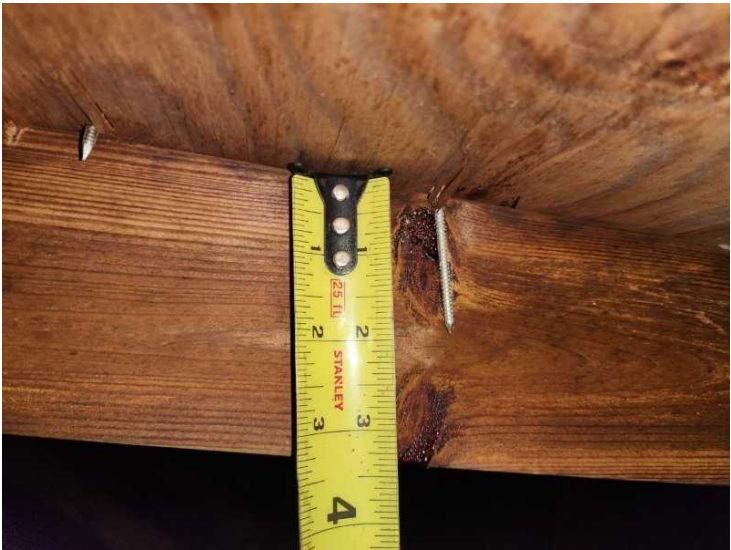
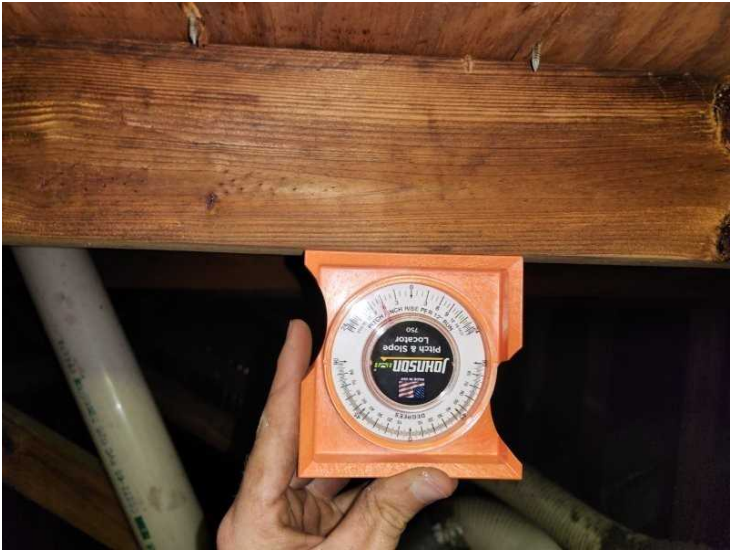
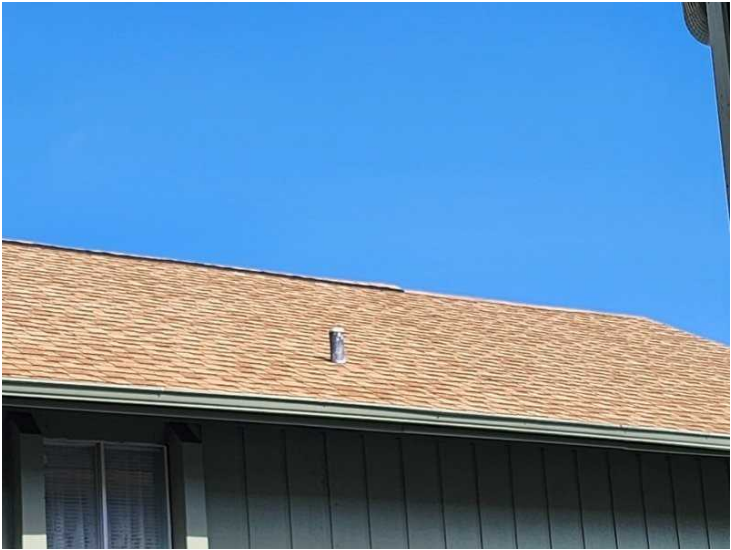
| <b>5. Roof Deck Attachment:</b><br>Comments: | <b>C. 182 psf</b><br>Inspection verified 1/2" plywood roof deck attached with 8d nails at a minimum 6" on the edge & 6" in the field. |
| <b>6. Roof to Wall Attachment:</b><br>Comments: | <b>B. Clips</b><br>Inspection verified hurricane clips fastened with a minimum of three nails. |

Roof Construction

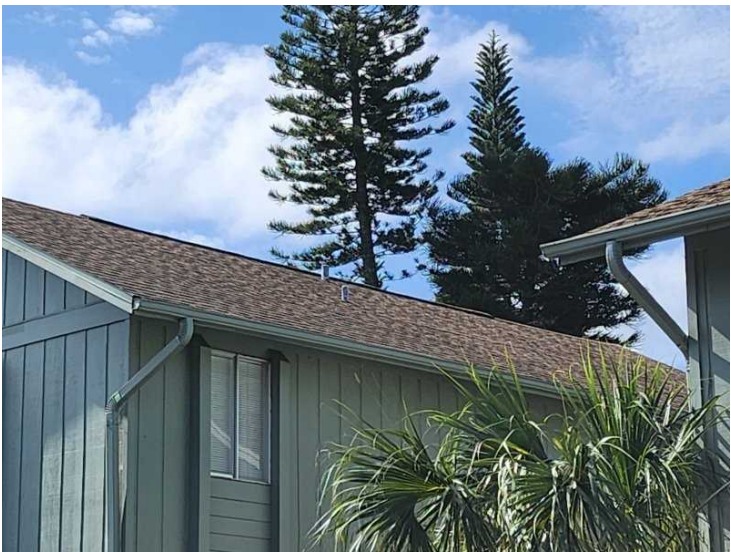
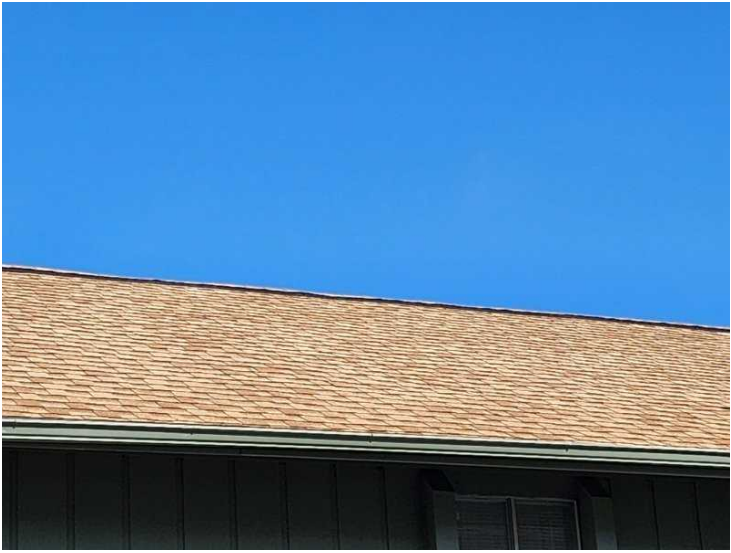
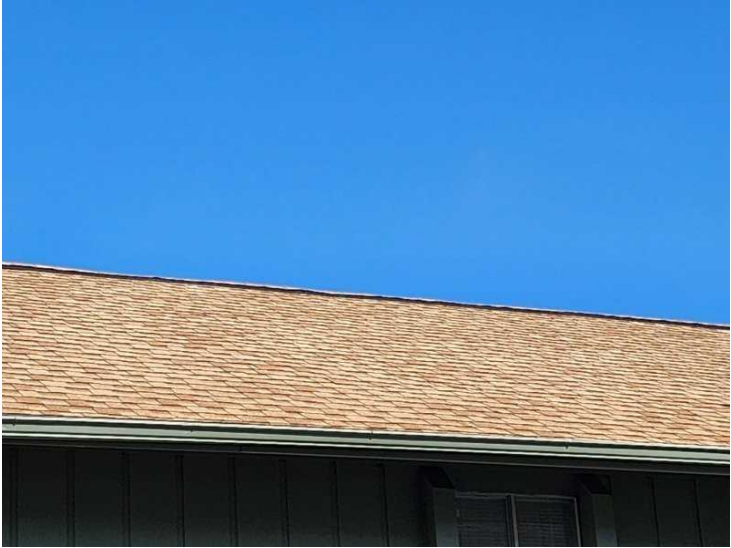
| <b>8. Sealed Roof Deck/SWR:</b><br>Comments: | <b>A. Sealed Roof Deck</b><br>SWR was verified at time of inspection. The Secondary Water Resistance verified is a self-adhering peel and stick. |

Roof Construction
