# Windstorm Mitigation Affidavit Report

Oak Lake Park I Condominium  
1960 Union St, Units 17, 18  
Clearwater, FL 33763

Prepared Exclusively for Oak Lake Park I Condominium Association, Inc.  
As of 04-03-2026 | FPAT File# MUD2626181

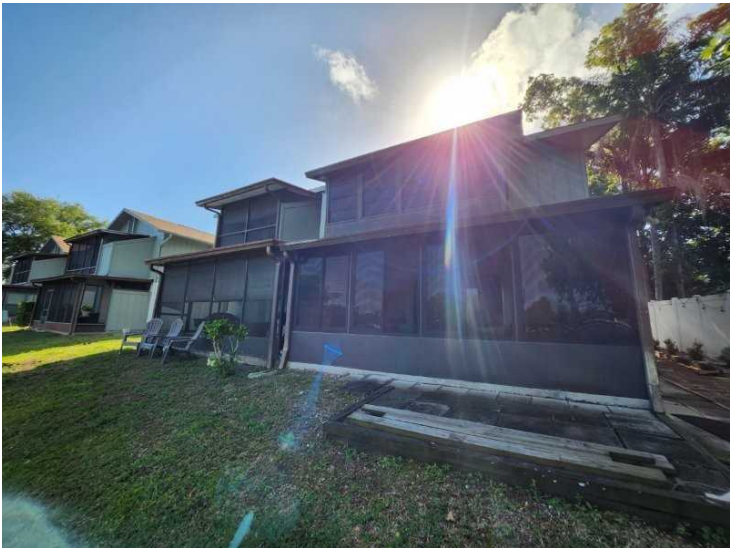
Roof Permit Information

Record BCP2019-100244:  
Building - Construction Permit  
Record Status: Completed

| <b>Project Name</b><br>1960 Union St<br>Online Permit - no roof 18 sq GAF shingles FL50124.1 B-20<br>and Soprema underlayment FL2569.1 B-14 4/22 pitch | <b>Property Owner Info:</b><br>MARY E NUTTLE *<br>1960 UNION ST APT 17<br>CLEARWATER FL 33763-2253 |

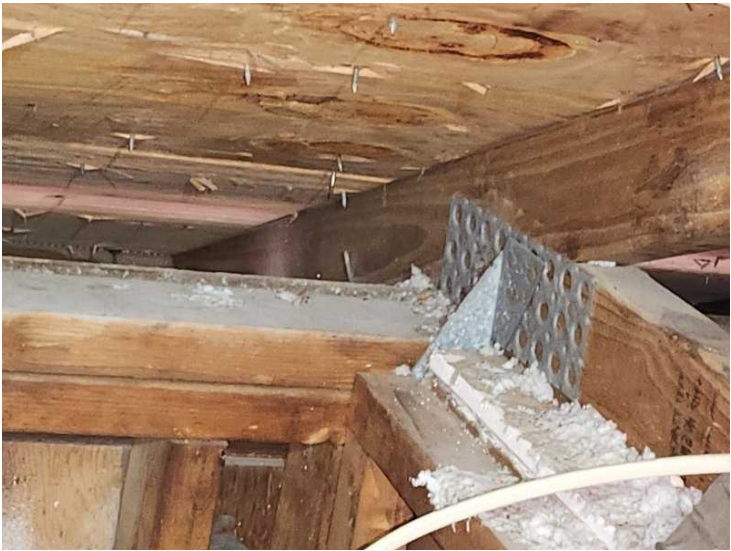
Roof Construction

| <b>5. Roof Deck Attachment:</b><br>Comments: | <b>C. 182 psf</b><br>Inspection verified 1/2" plywood roof deck attached with 8d nails at a minimum 6" on the edge & 6" in the field. |
| <b>6. Roof to Wall Attachment:</b><br>Comments: | <b>B. Clips</b><br>Inspection verified hurricane clips fastened with a minimum of three nails. |
