# Windstorm Mitigation Affidavit Report

Oak Lake Park I Condominium  
1960 Union St, Units 19, 20  
Clearwater, FL 33763

Prepared Exclusively for Oak Lake Park I Condominium Association, Inc.  
As of 04-03-2026 | FPAT File# MUD2626181

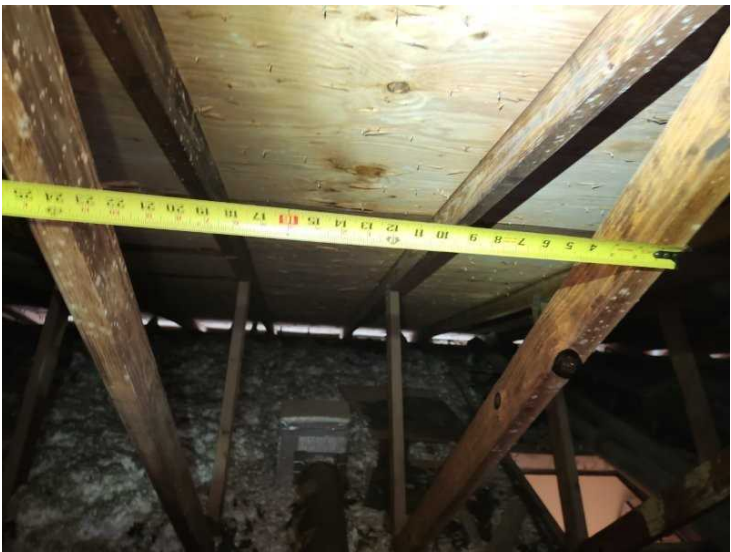
Roof Construction

| <b>5. Roof Deck Attachment:</b><br>Comments: | <b>C. 182 psf</b><br>Inspection verified 1/2" plywood roof deck attached with 8d nails at a minimum 6" on the edge & 6" in the field. |
| <b>6. Roof to Wall Attachment:</b><br>Comments: | <b>B. Clips</b><br>Inspection verified hurricane clips fastened with a minimum of three nails. |

A close-up photograph of the roof construction. It shows wooden beams and joists. A metal bracket is used to secure a beam. There is some insulation visible between the beams. The roof appears to be under construction or repair.
