# Windstorm Mitigation Affidavit Report

Oak Lake Park I Condominium  
1960 Union St, Units 5, 6  
Clearwater, FL 33763

Prepared Exclusively for Oak Lake Park I Condominium Association, Inc.  
As of 04-03-2026 | FPAT File# MUD2626181

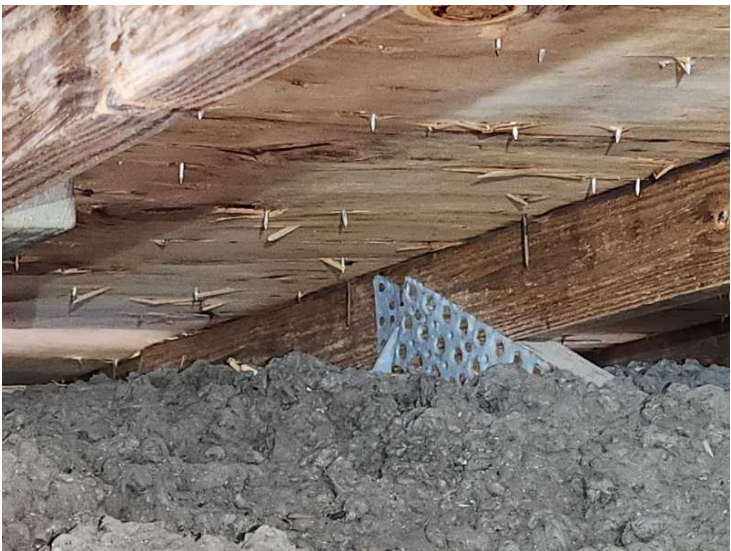
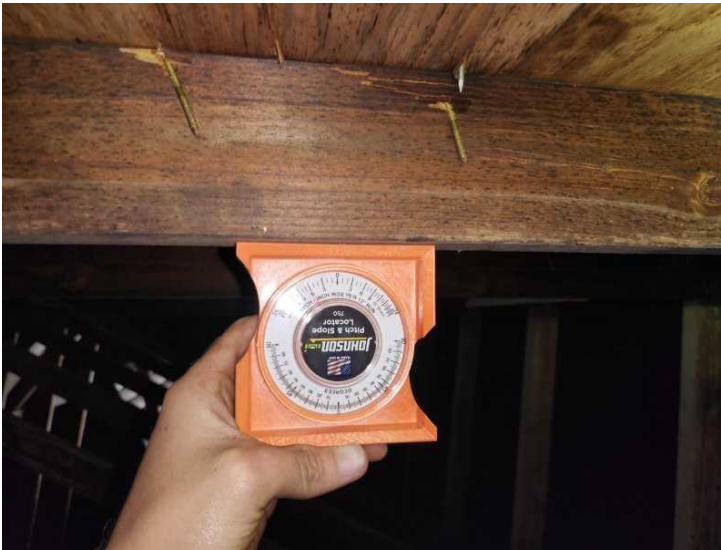
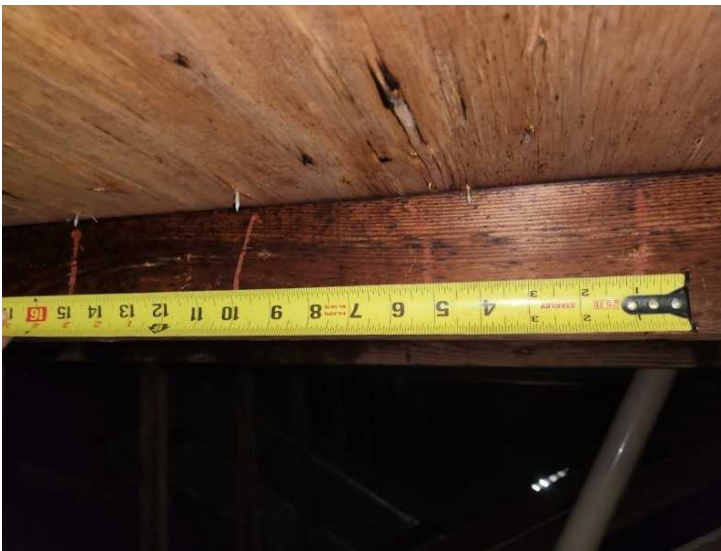
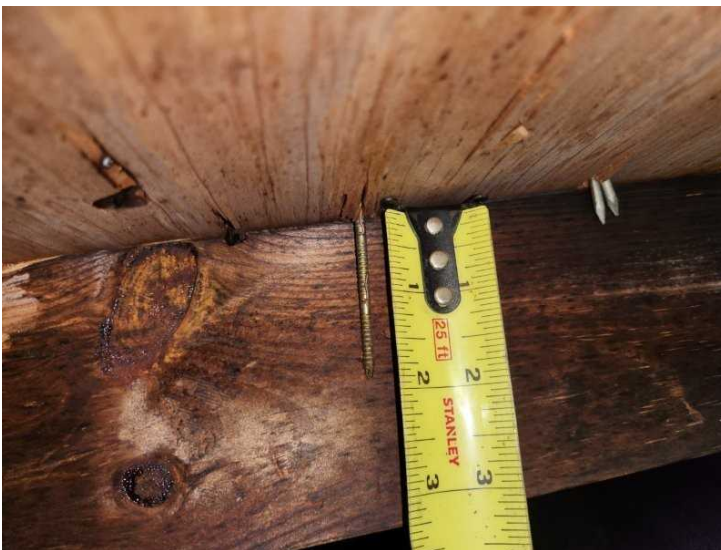
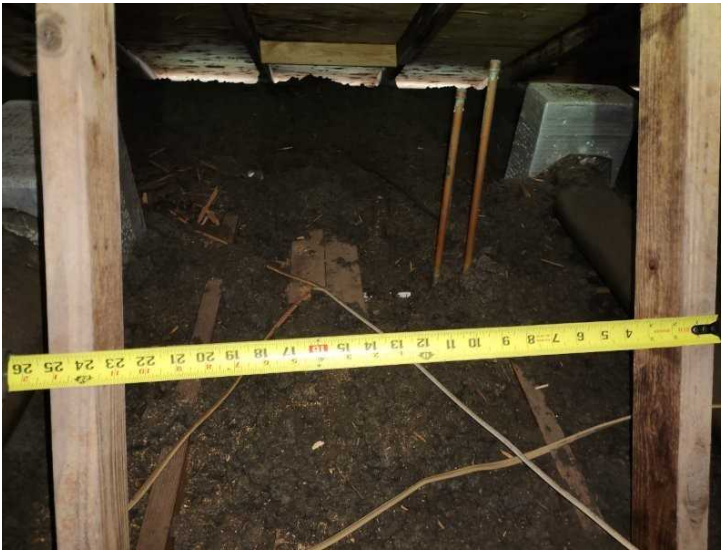
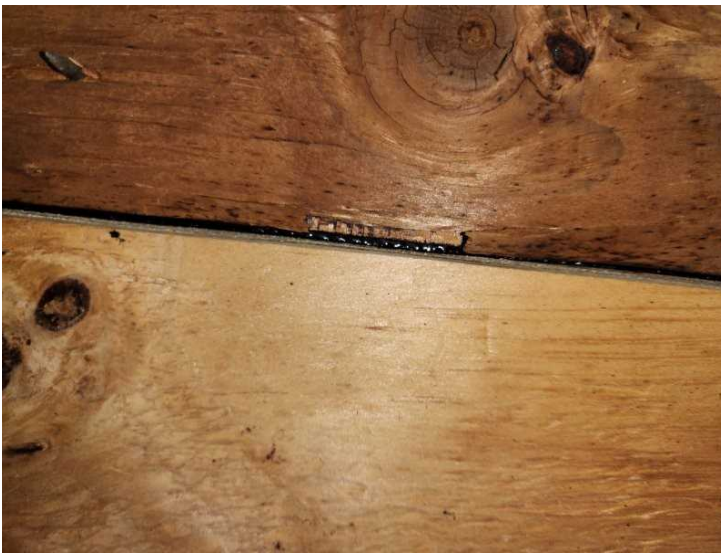
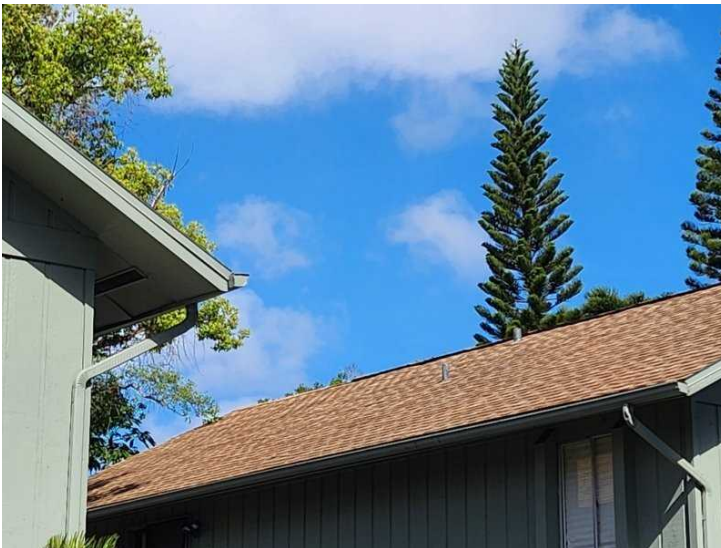
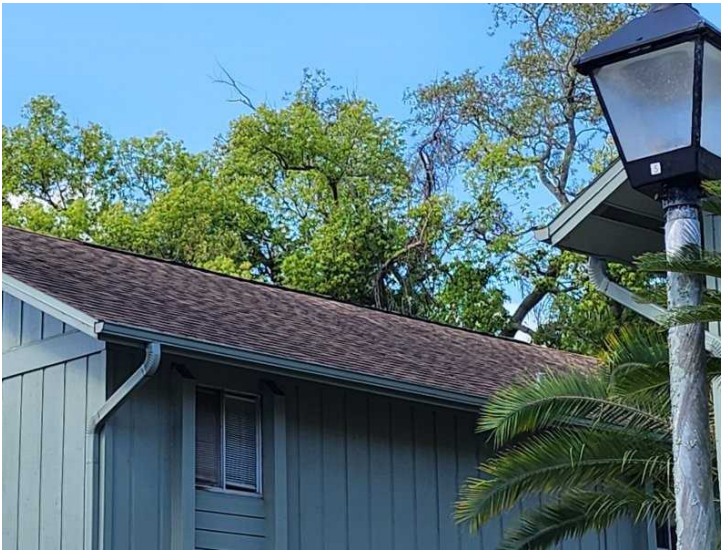
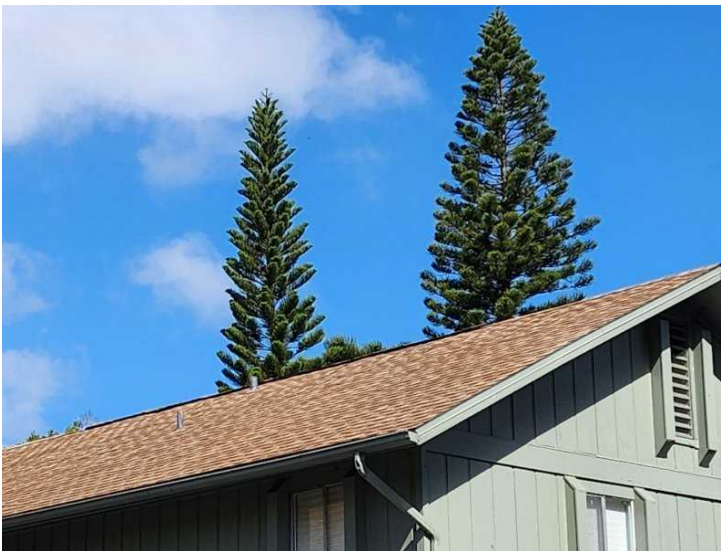
Roof Construction

| <b>5. Roof Deck Attachment:</b><br>Comments: | <b>C. 182 psf</b><br>Inspection verified 1/2" plywood roof deck attached with 8d nails at a minimum 6" on the edge & 6" in the field. |
| <b>6. Roof to Wall Attachment:</b><br>Comments: | <b>B. Clips</b><br>Inspection verified hurricane clips fastened with a minimum of three nails. |
| <b>8. Sealed Roof Deck/SWR:</b><br>Comments: | <b>A. Sealed Roof Deck</b><br>SWR was verified at time of inspection. The Secondary Water Resistance verified is a self-adhering peel and stick. |
