# Windstorm Mitigation Affidavit Report

Oak Lake Park I Condominium  
1960 Union St, Units 9, 10  
Clearwater, FL 33763

Prepared Exclusively for Oak Lake Park I Condominium Association, Inc.  
As of 04-03-2026 | FPAT File# MUD2626181

# Uniform Mitigation Verification Inspection Form

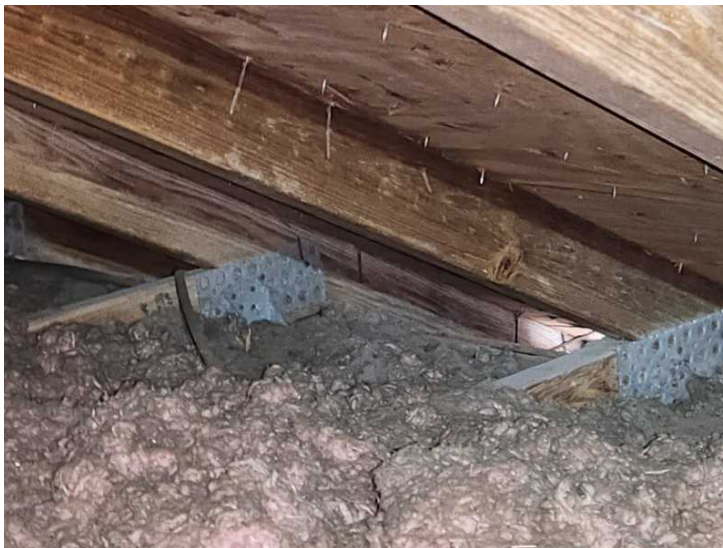
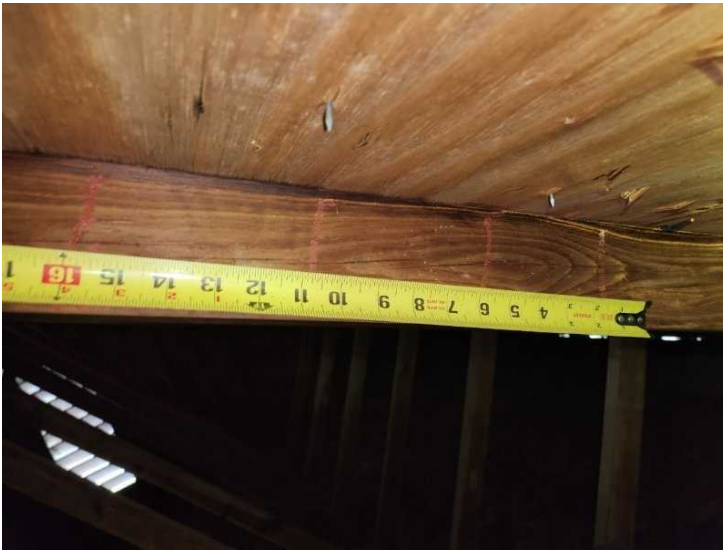
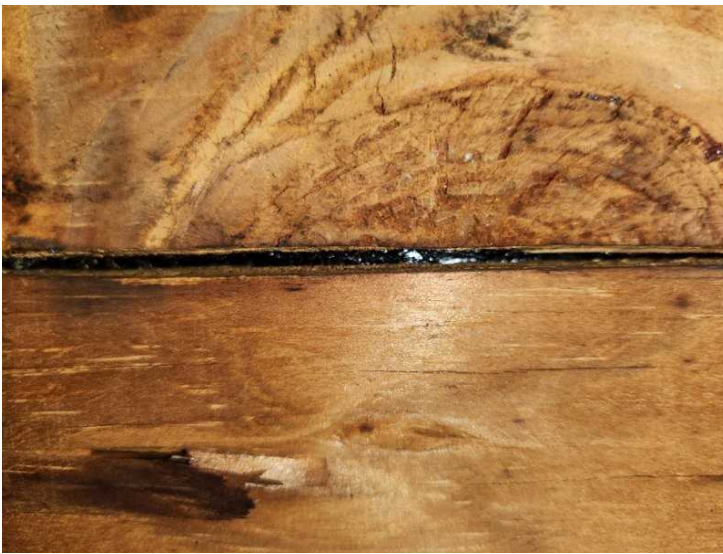
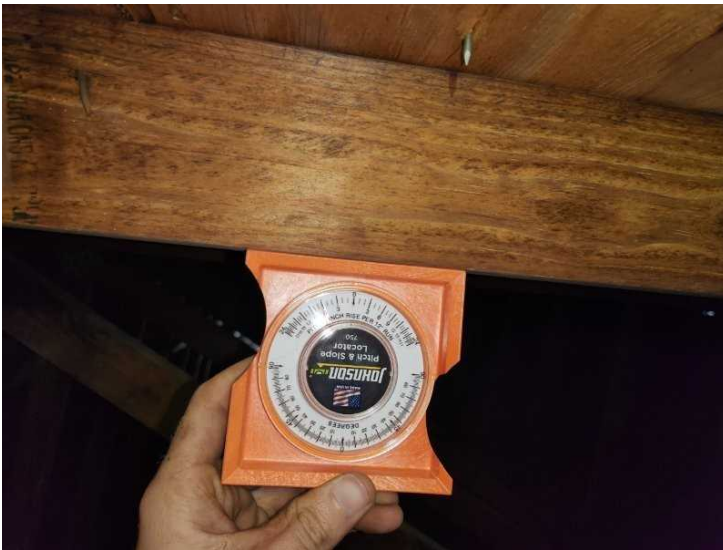
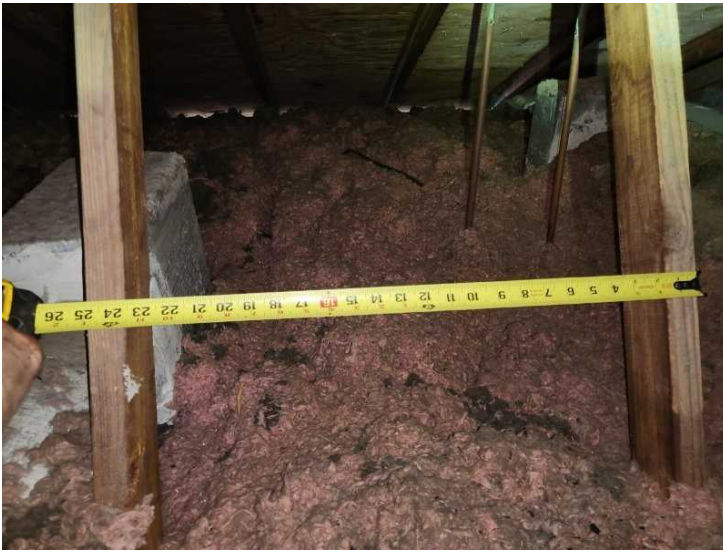
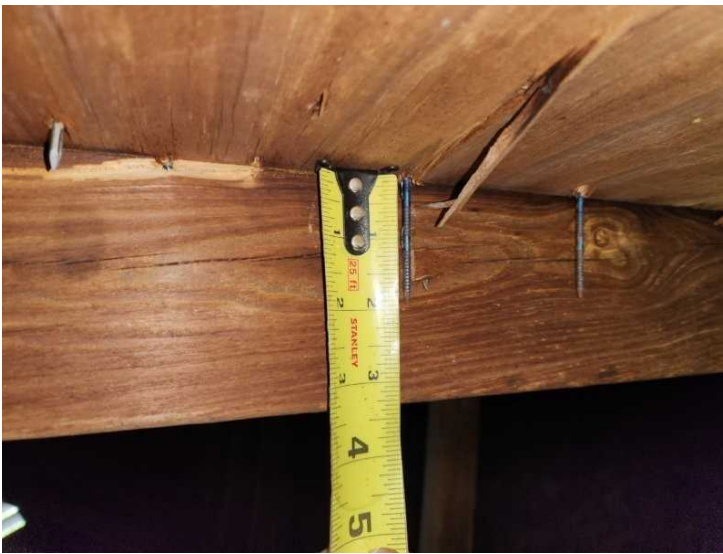
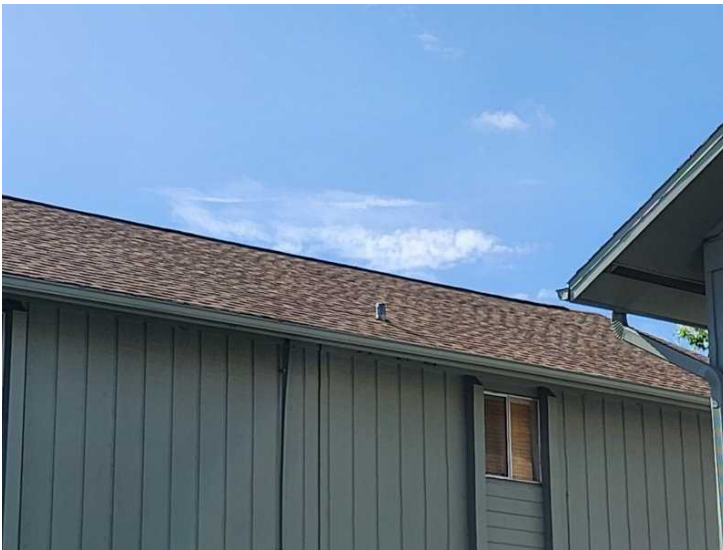
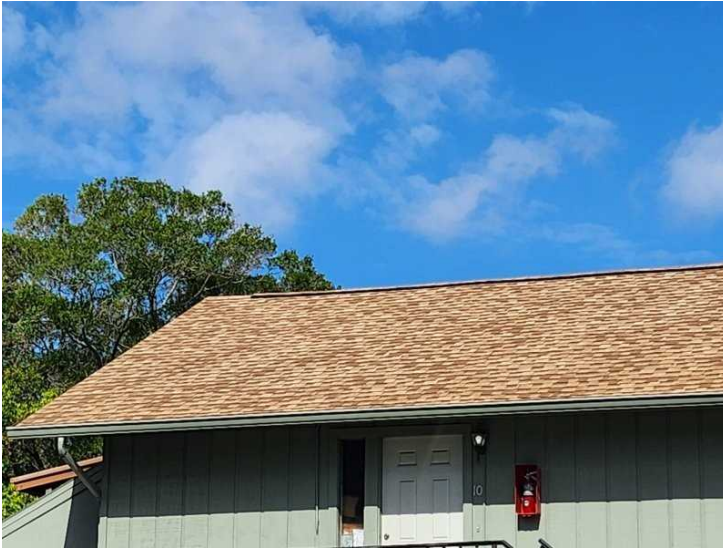
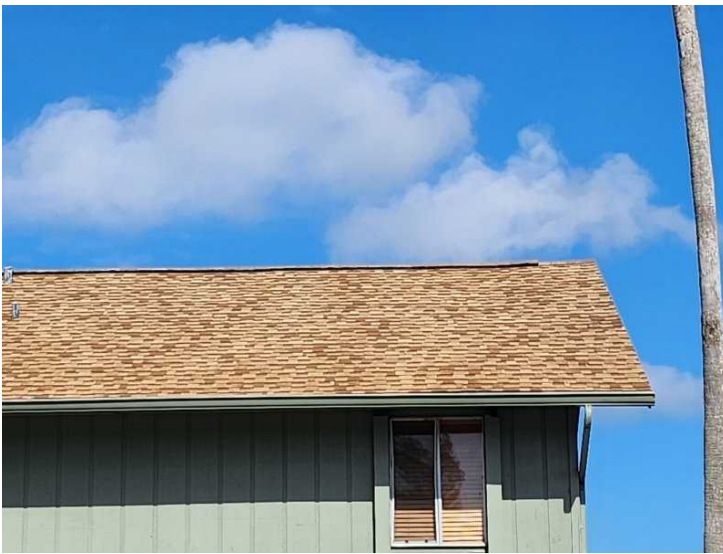
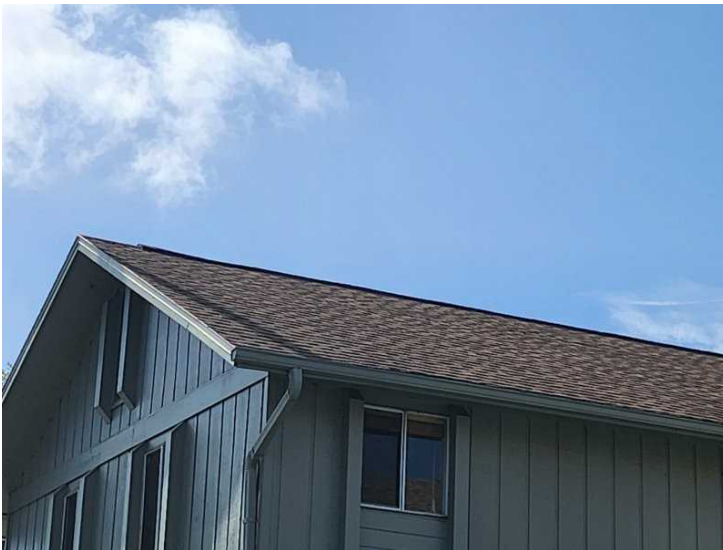
Roof Construction

| <b>5. Roof Deck Attachment:</b><br>Comments: | <b>C. 182 psf</b><br>Inspection verified 1/2" plywood roof deck attached with 8d nails at a minimum 6" on the edge & 6" in the field. |
| <b>6. Roof to Wall Attachment:</b><br>Comments: | <b>B. Clips</b><br>Inspection verified hurricane clips fastened with a minimum of three nails. |
| <b>8. Sealed Roof Deck/SWR:</b><br>Comments: | <b>A. Sealed Roof Deck</b><br>SWR was verified at time of inspection. The Secondary Water Resistance verified is a self-adhering peel and stick. |
